Subject; Robert Scarlett – Residential Hazard Tree

# Arborist Report

## Tree Risk Assessment

**20 Oak Ridge Dr.**  
**Redway, CA 95560**  
**3/23/2026**

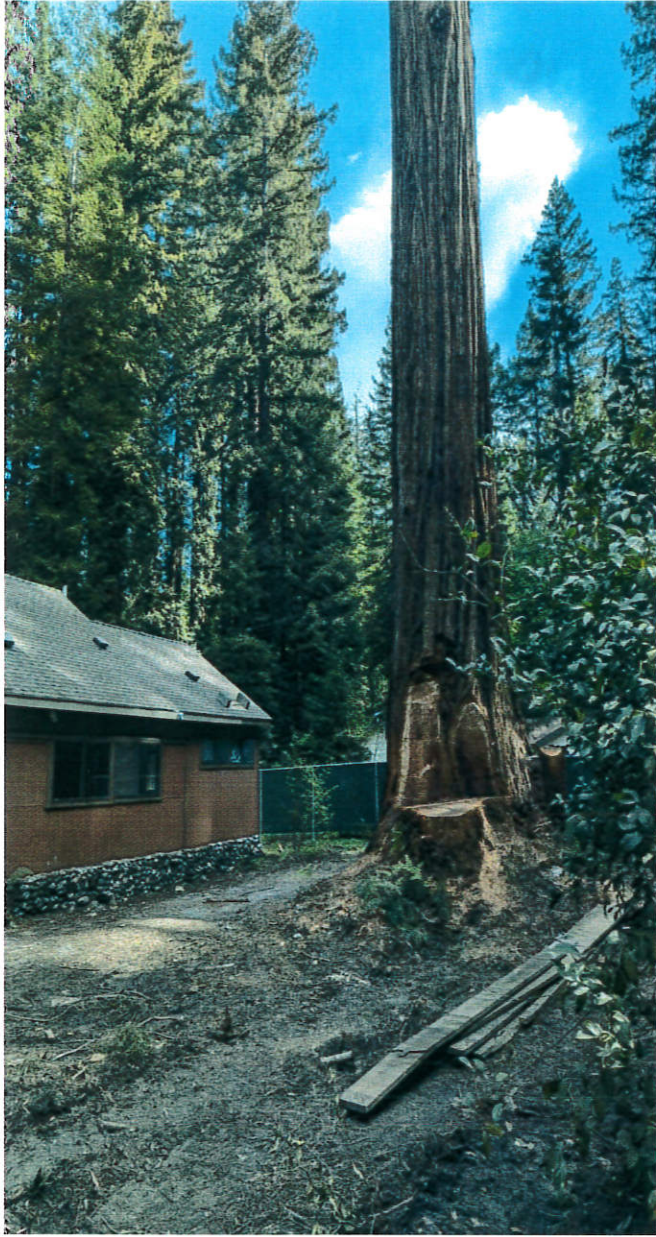
One very large Coastal Redwood (*Sequoia sempervirens*) stands in the southeast corner of a residential parcel located on the corner of Oakridge Dr and Eel River Ln in Redway. The tree measures 118" in diameter at breast height and stands at over 250'. Directly north of the tree by approximately 20 feet is the house, and to the east, there is a neighboring property with a house that sits within striking distance of the tree. To the south, there are high voltage powerlines within 30 feet of the trunk and Briceland Rd lies just beyond the power lines.

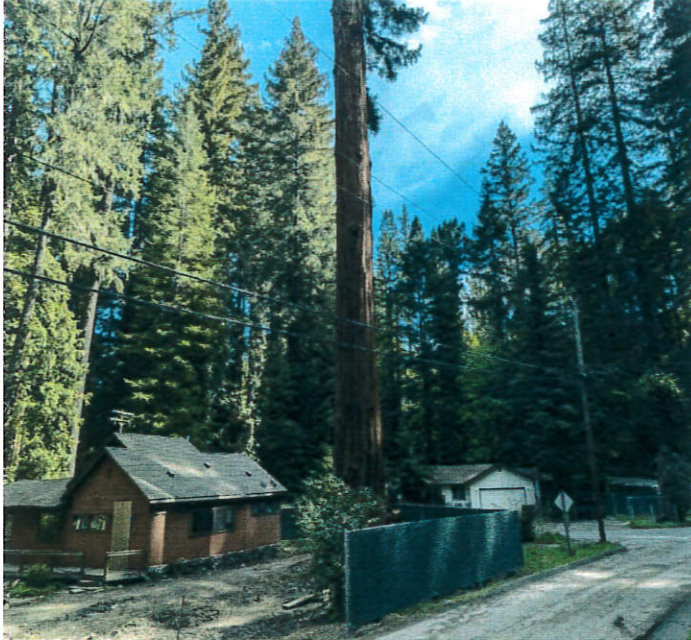
Due to the home being built in such close proximity, the tree has likely experienced damage from the home's construction in the form of soil compaction and damaged roots. At the time of the site visit, there was some severe damage inflicted to the tree trunk. There was a very large cut made along the base of the tree just above the root flare and into the trunk. This cut was likely done to remove a smaller stem protruding from the side of the tree. However, this cut leaves a very large wound on the trunk which will almost certainly facilitate the presence of rot and decay within the trunk at a faster rate. In addition, almost all of the lower canopy has been removed resulting in an unnaturally raised crown. The tree has been known to shed large limbs over the years, striking and damaging the house on numerous occasions. The tree stands quite a bit taller than any others in the immediate vicinity and appears to be in a spot where it would be directly exposed to heavy winds during any wind events.

Mitigation options such as pruning would be unfeasible without retaining a high level of risk due to the lack of remaining canopy and the severe trunk damage the tree has suffered. It would be unreasonable to expect the residents of this house to continue to live at this address without addressing the risk posed by this tree. Therefore, I would recommend the immediate removal of this tree due to the potential of severe consequences that would result in the case of this tree's failure.
